Recommendations to Improve Pedestrian & Bicycle Safety for the Conway Community in Stockton

October 2018

By Esther Rivera, Tony Dang, Jaime Fearer, California Walks; Tracy McMillan, Garrett Fortin, UC Berkeley Safe Transportation Research & Education Center

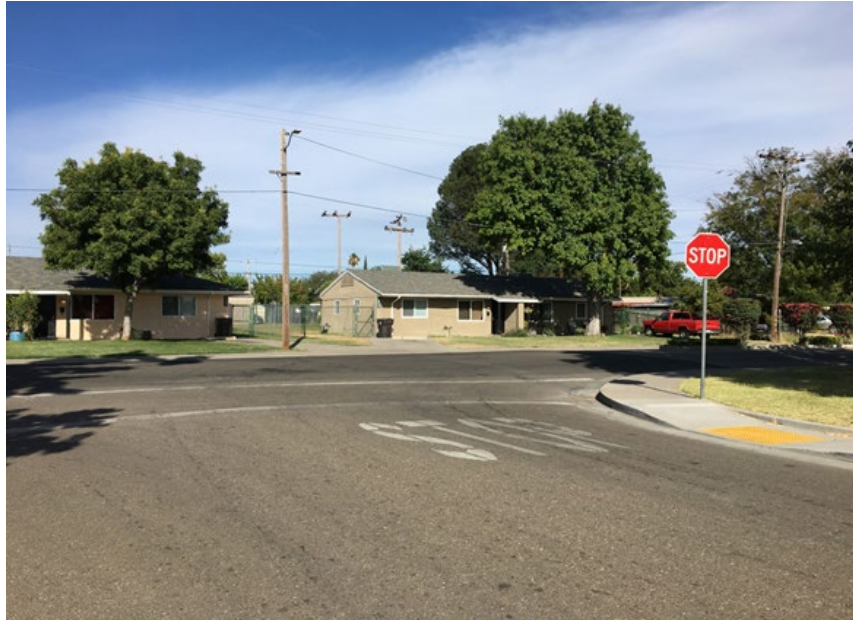
A Number of intersections in the Conway community have newer, ADA-compliant curb ramps. Many of these ramps, however, are not aligned with the marked crosswalks and have been placed behind the stops signs and STOP road markings

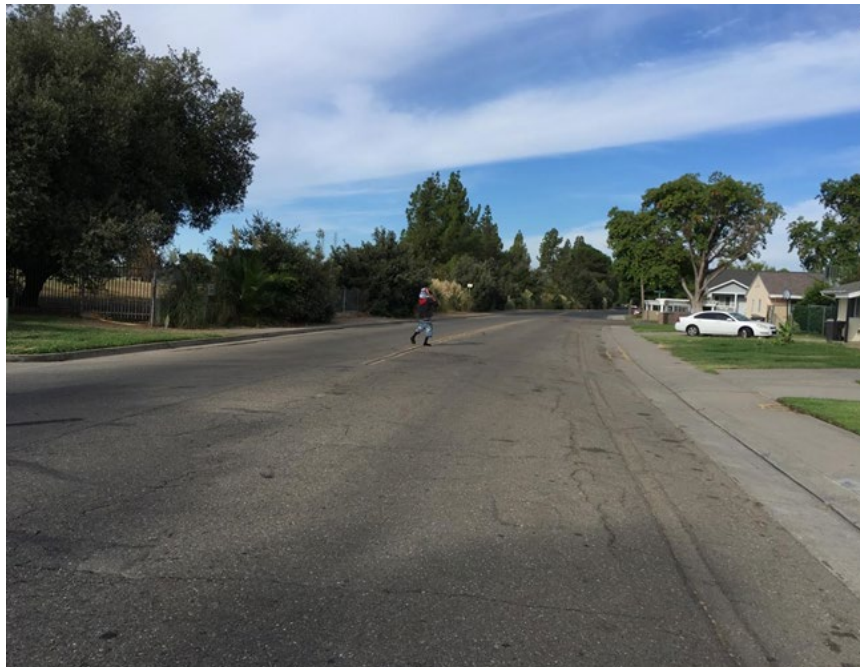
Residents commonly legally cross outside of crosswalks to access Van Buskirk Community Center and Park on the south side of Houston Avenue from their homes on the north side.

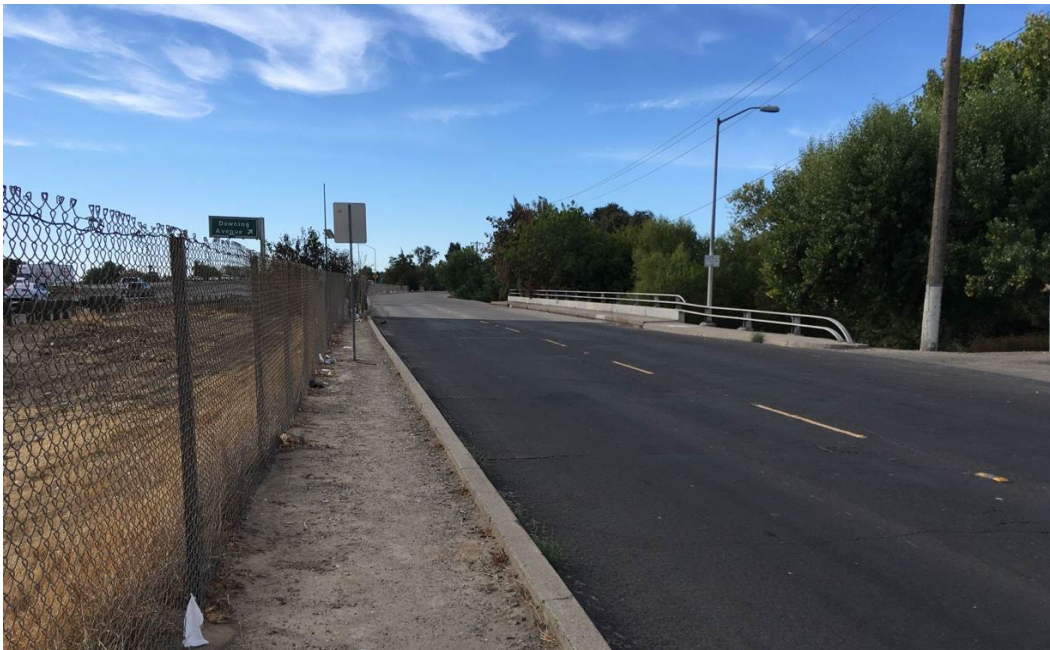
Facing south on Manthey Avenue with the sole section of sidewalk on the bridge crossing the slough. The well-worn path indicates residents are choosing to walk on the east side of Manthey Road to avoid having to cross the road multiple times because the sidewalk ends abruptly after the slough.

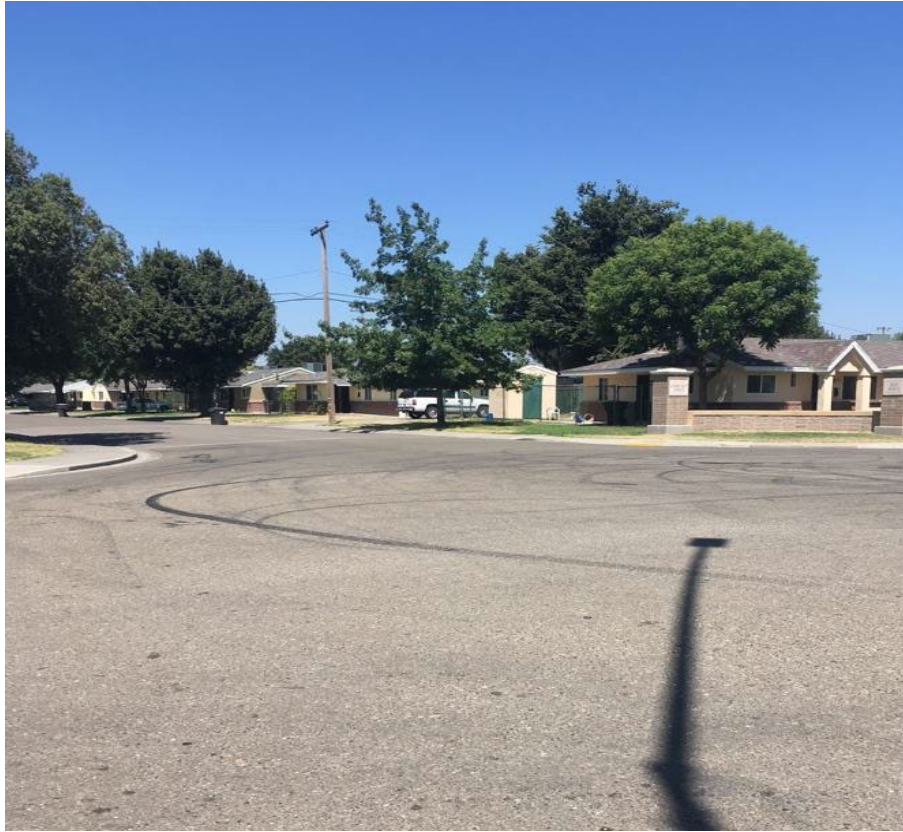
Wide uncontrolled intersection at Flint Avenue/Connecticut Avenue.

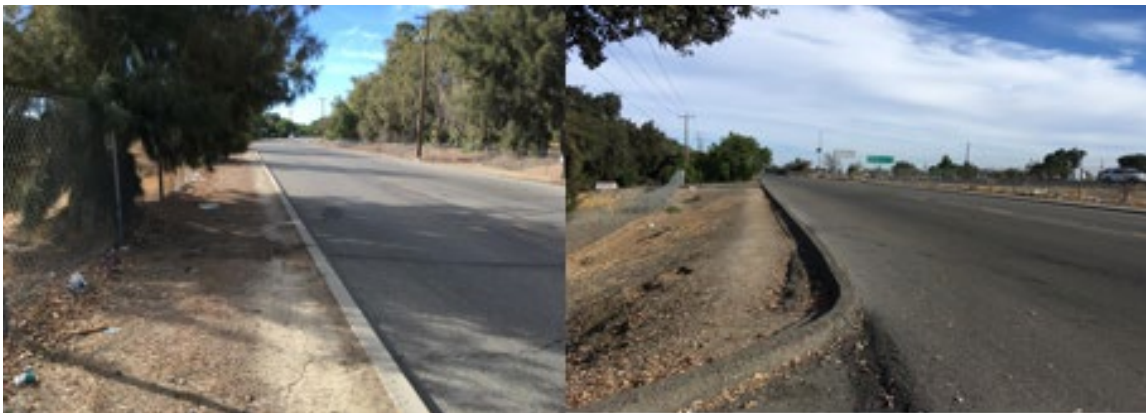
Well-worn foot paths on either side of Manthey Road indicate residents are using these routes frequently. Residents using wheelchairs or other mobility assistive devices are unable to use these foot paths and must travel in the street.

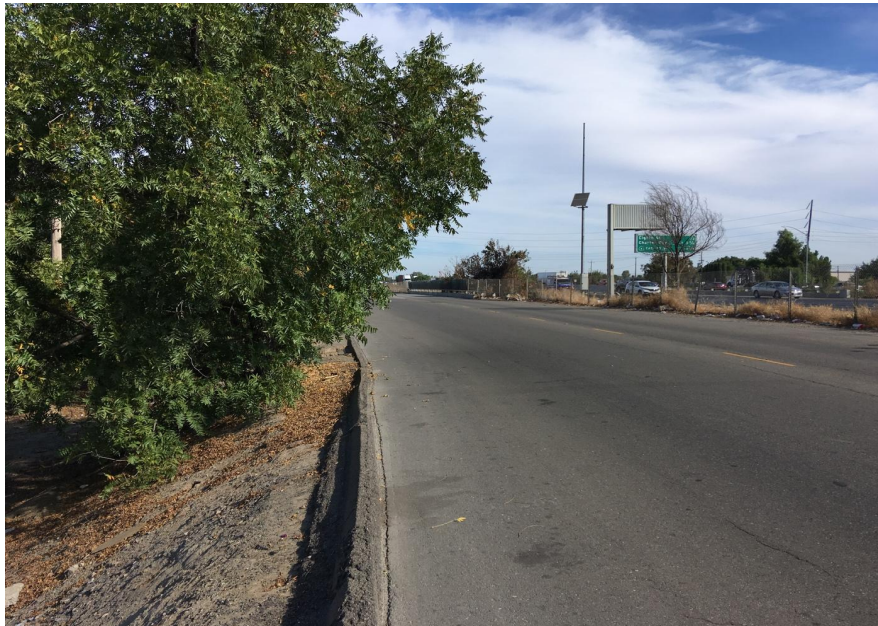
Traveling northbound on Manthey Road, the foot path on the west side becomes un navigable, forcing residents to walk in the street where they are obscured from oncoming traffic by overgrown vegetation.

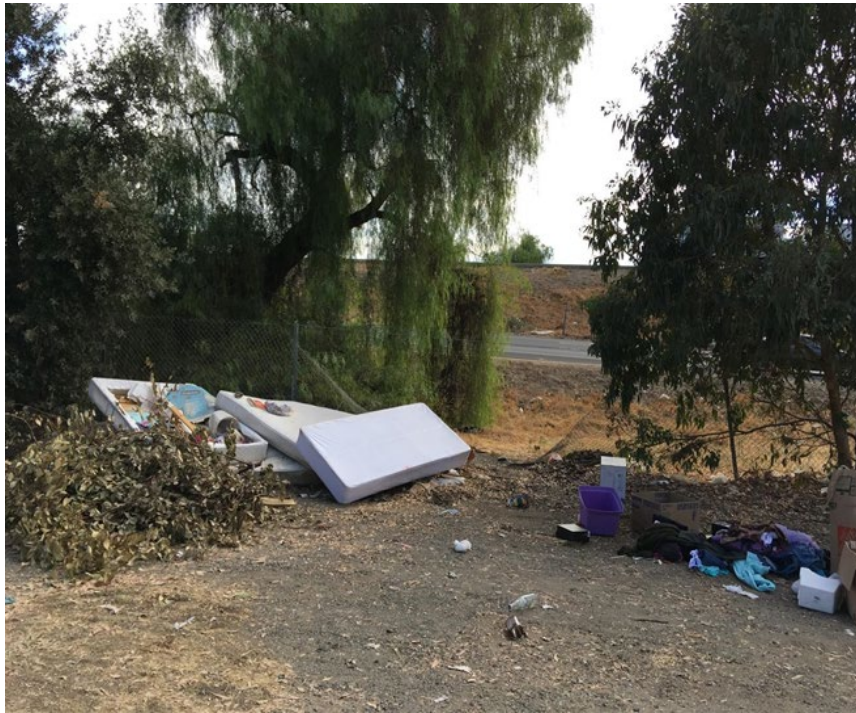
Frequent illegal dumping along Manthey Road exacerbates residents' feelings of neglect by City, County, and state agencies.

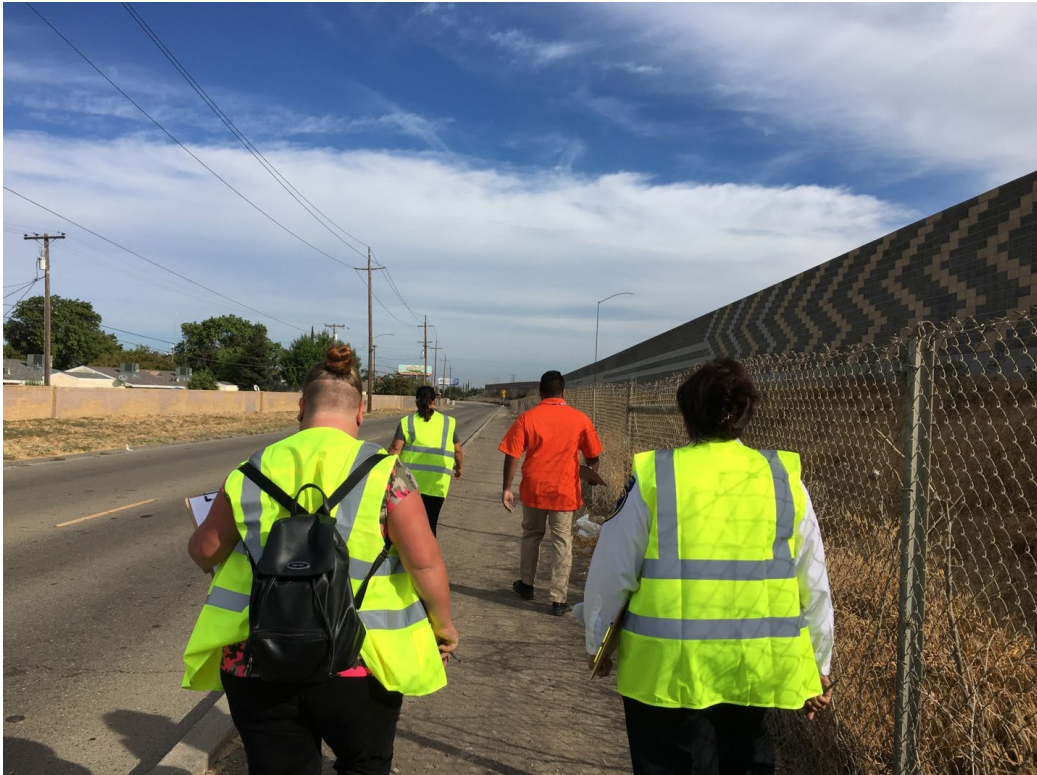
The lack of sidewalks on Manthey Road forces people to walk on an unpaved and unmaintained shoulder on the east side of the road.

- **Sidewalk Improvements:** Participants identified installing sidewalks along Manthey Road as a priority, given Manthey Road’s role as a main route connecting residents to the grocery store and convenience store. Several participants noted the need for cultivating more support from elected officials to leverage and shift funds to support a sidewalk project. City Councilmember Jesús Andrade’s office has been active in the community, especially since the recent collisions involved three pedestrians. Participants outlined the following steps needed to make the improvements possible:

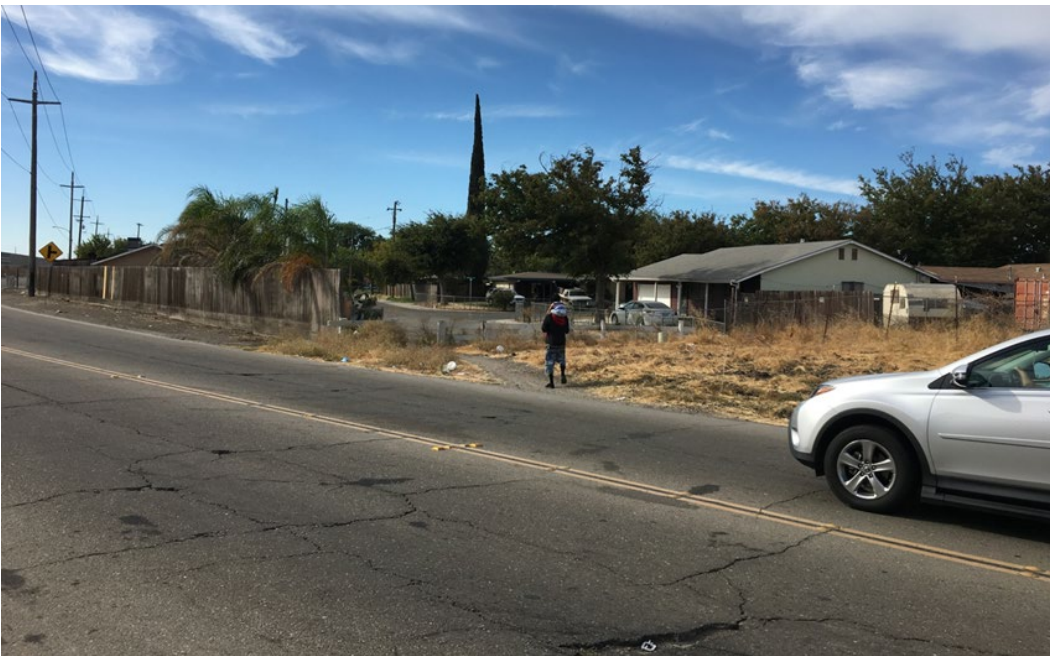
An informal and unpaved footpath provides direct access into the neighborhood from the California Stop convenience store. This path is just north of a blind curve on Manthey Road.

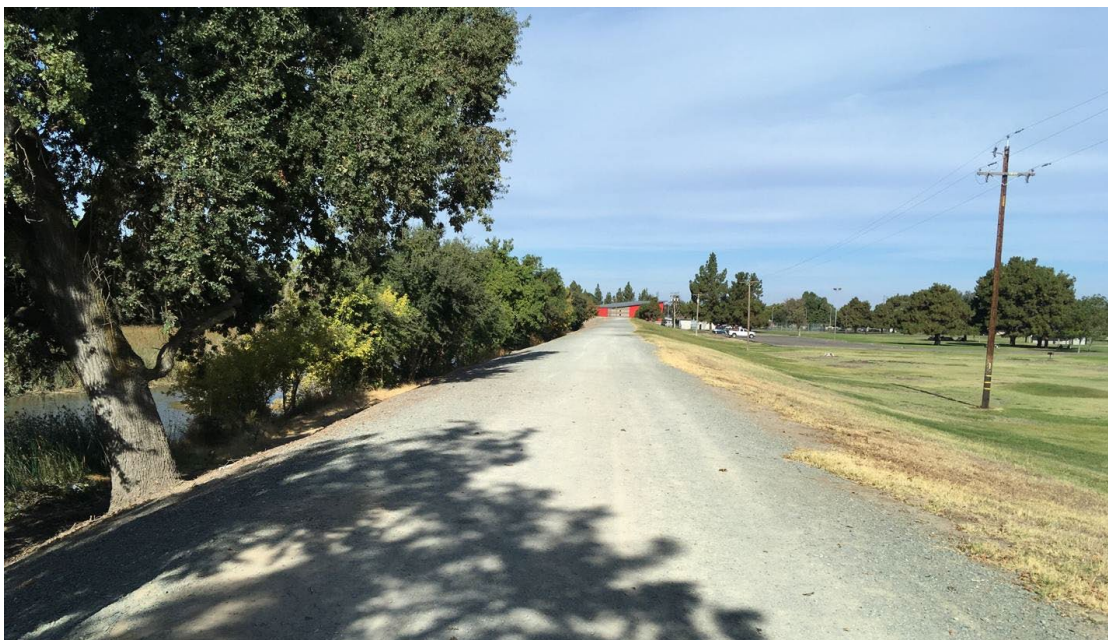
Participants noted the potential for leveraging the existing maintenance pathway on the levee to create a greenway that could serve as a sidewalk alternative to Manthey Road.

- **Apply for Urban Greening Grant - Van Buskirk Green Pathways:** During the walking assessment, participants observed the neighborhood's proximity to the San Joaquin River and Walker Slough as a positive community asset. In particular, participants on Route 3 saw great potential in transforming the current levee maintenance road into a pathway for residents to use and to enjoy nature. Due to the pathway's proximity to the Van Buskirk Community Center and Park, the levee road could serve as the backbone of a network of green pathways in the community center and park area and provide an alternative route to Manthey Road for residents. The Project Team **recommends the City of Stockton work with Conway residents to develop and submit an application to the state [Urban Greening Grant Program](#) during the next grant cycle** focused on transforming the levee maintenance road into a pedestrian and bicycle pathway and on constructing a roughly 0.3 mile asphalt path in the park parallel to Manthey Road from Houston Avenue to the levee. With these two paths, residents would be able to travel half the distance south toward Downing Avenue with full physical separation from traffic. The project would also provide residents with additional facilities with which to be physically active, as well as increase access to the area's scenic resources.

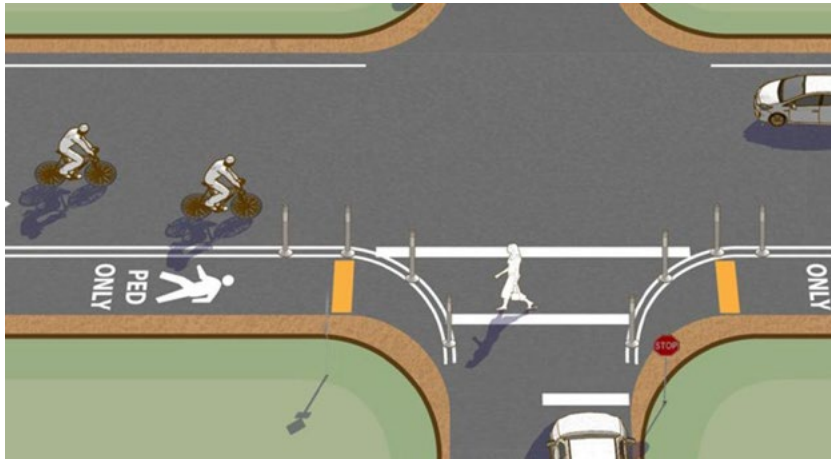
Example of a pedestrian lane treatment in lieu of a dedicated sidewalk or sidewalk. Image Credit: Federal Highway Administration.

- **Explore Feasibility of Pedestrian Lane on Manthey Road:** Echoing workshop participants' priorities and based on our assessment, Cal Walks and SafeTREC strongly recommend the City of Stockton work toward installing sidewalks on Manthey Road. Due to the potentially high costs and long-term timeline for installing sidewalks on Manthey Road, however, the Project Team ***recommends the City of Stockton explore the feasibility of a creating a safer, more robust shoulder area in the short-term*** that is clearly delineated from the travel lanes with flexible, retro-reflective bollards or soft-hit posts installed at regular intervals to reinforce the shoulder as a pedestrian-only space. This type of treatment is referred to as a "pedestrian lane" and is endorsed by the Federal Highway Administration as a context-sensitive solution for small towns and rural communities.⁴

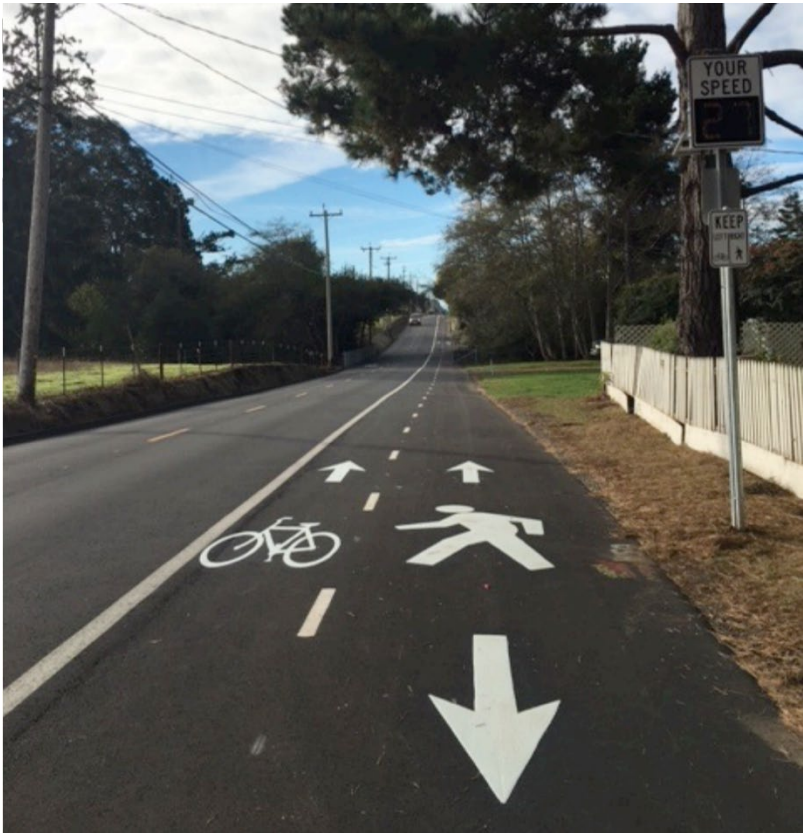
Example of a pedestrian lane treatment in McKinleyville, CA. Population: 15,177. Photo Credit: Redwood Community Action Agency.

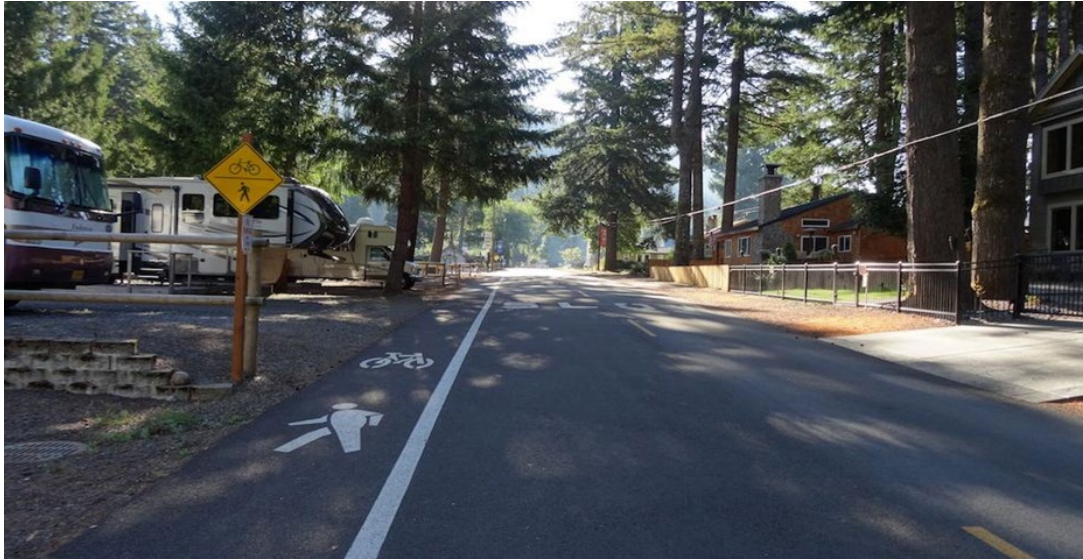
Example of a pedestrian lane treatment in Detroit, OR. Population: 200.

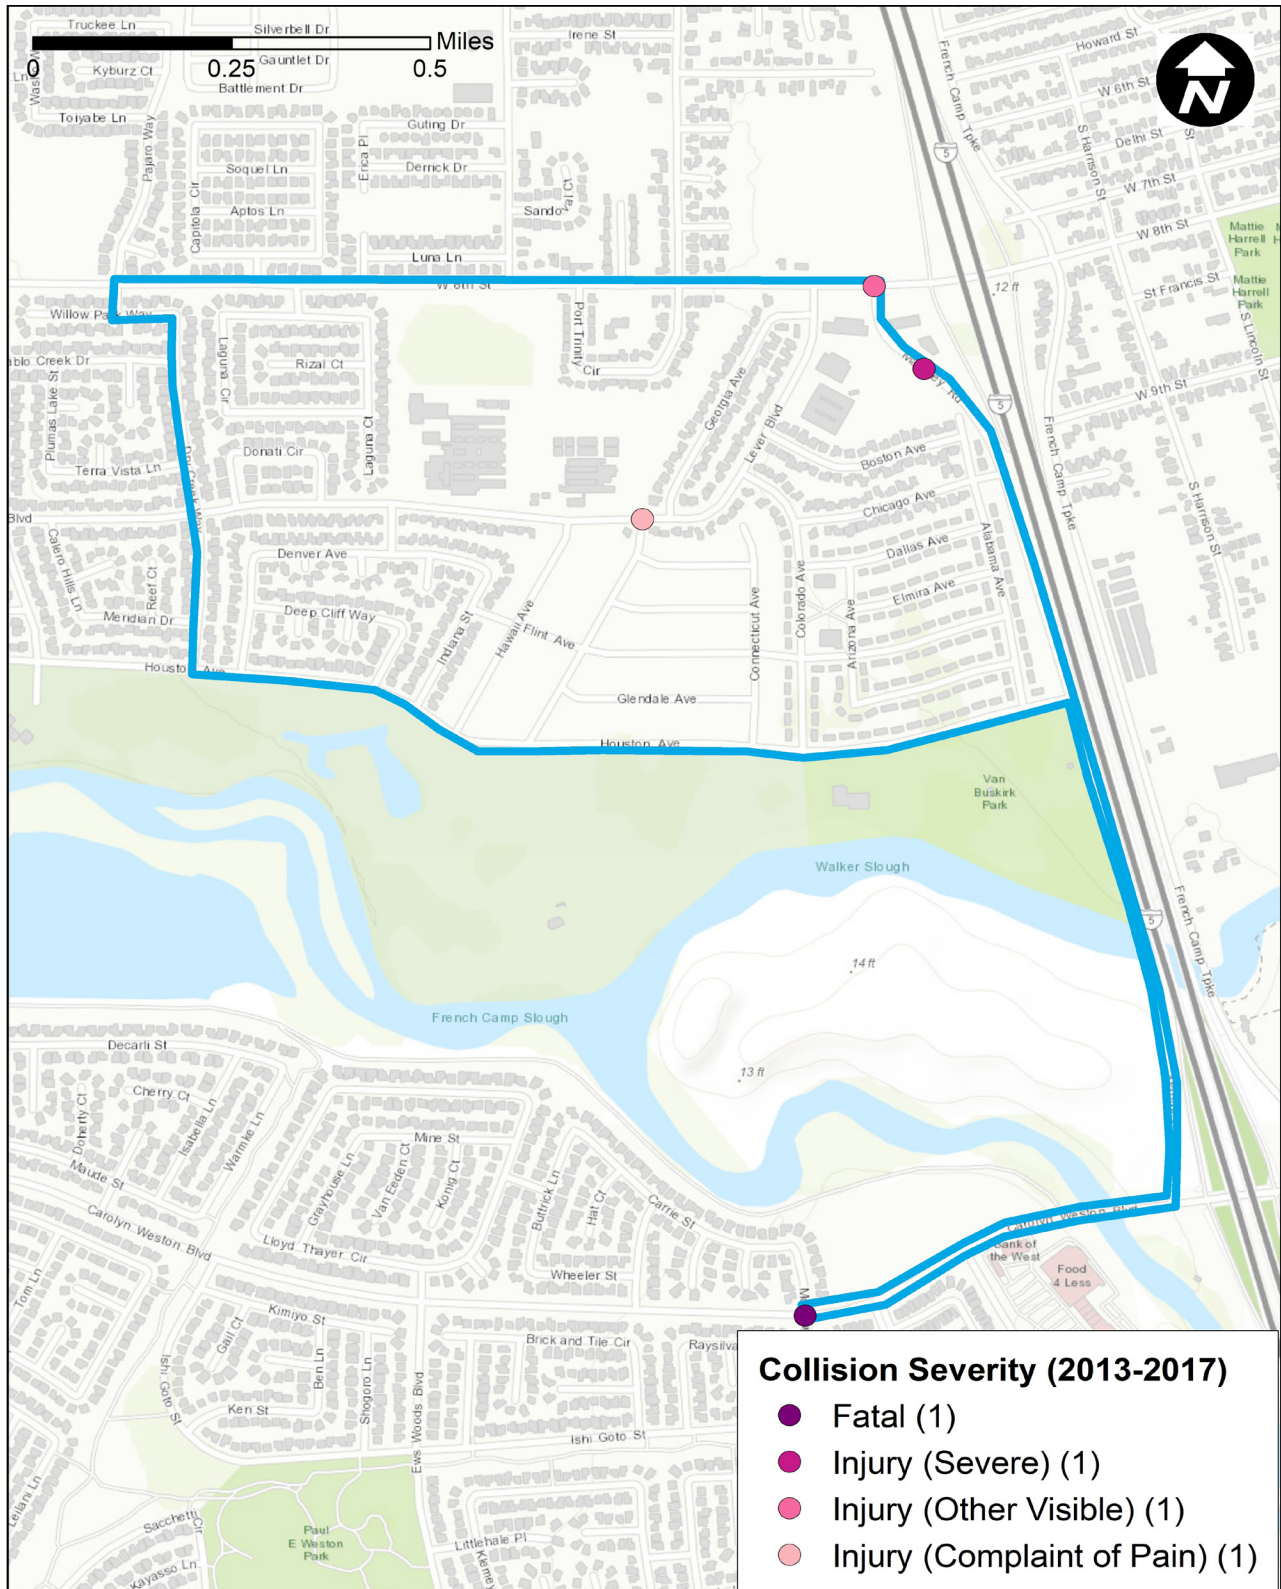
Pedestrian Collisions 2013-2017

4 collisions mapped for the Conway Homes neighborhood in Stockton, CA.

Data Source: California Statewide Integrated Traffic Records System (SWITRS). Collision data for 2015 and 2016 are provisional as of November 2017.

Between 2013-2017, there were four (4) pedestrian collisions, including one (1) pedestrian fatality and one (1) pedestrian severe injury in the Conway community. Collisions in this time period were concentrated on Manthey Road and 8th Street and primarily occurred in the evening from 6:00 p.m. to 11:59 p.m. The primary collision factor for pedestrian collisions was the pedestrian failure to cross at a crosswalk between adjacent traffic signal controlled intersections (50%).² While pedestrian collisions have generally been on a downward trajectory, 2017 experienced a marked increase in pedestrian collisions.
