RECOMMENDATIONS TO IMPROVE PEDESTRIAN SAFETY IN THE CITY OF FRESNO

September
2015

Recommendations to Improve Pedestrian Safety in the City of Fresno

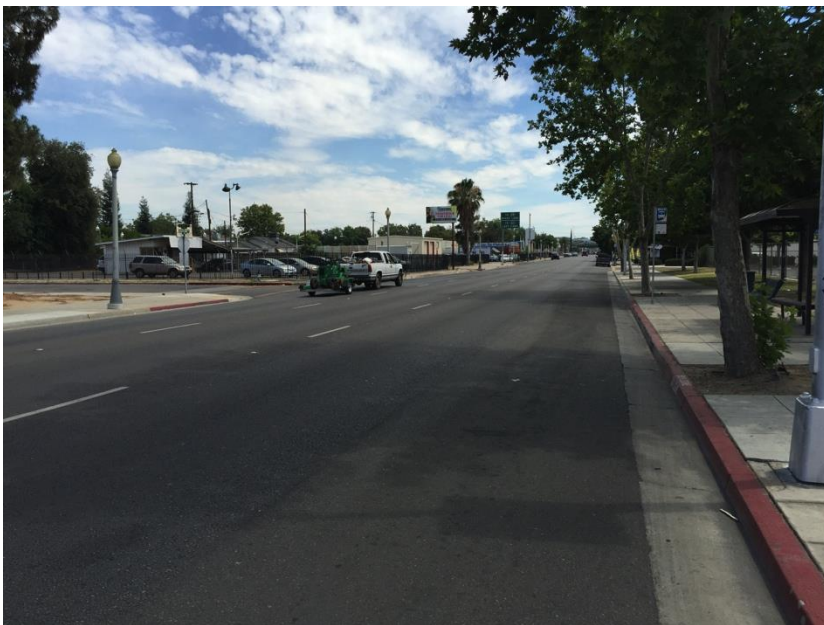
LACK OF MARKED CROSSING AT T-INTERSECTION LEADING TO A BUS STOP ON BLACKSTONE AVENUE

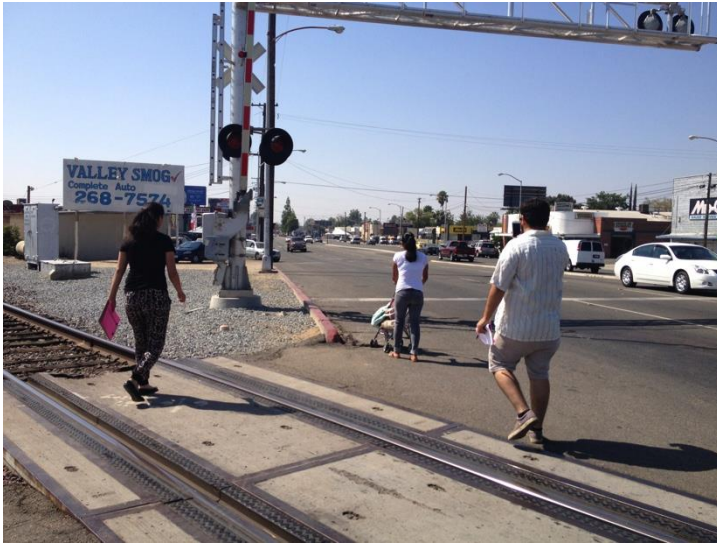
While sidewalks are mostly present along Ventura Street/Kings Canyon Road and Blackstone Avenue, there are instances where the sidewalk abruptly ends. Additionally, ADA-compliant curb ramps are largely missing where sidewalks are missing. Lastly, the frequent driveways, particular along Blackstone Avenue, present a number of challenges for people walking. First, the ingress/egress of vehicles increased potential conflicts between drivers and pedestrians, particularly due to driver inattention when exiting driveways. Secondly, the frequent driveways make it difficult to navigate in a wheelchair or using other mobility-assistance devices due to the steep and possibly non ADA-compliant cross slopes. Combined, these challenges may impact safe travel to the proposed BRT stations.

SIDEWALK ABRUPTLY ENDS ON EITHER SIDE OF RAILROAD CROSSING ALONG BLACKSTONE AVENUE FORCING PEDESTRIANS

- **Prioritize Sidewalk Repair & Maintenance:** Where sidewalks currently exist on Blackstone Avenue/Kings Canyon Road, participants strongly supported prioritizing repair and maintenance of these sidewalks in order to ensure access to the BRT stations and to maximize potential ridership. Participants noted sidewalks in disrepair and numerous sidewalk obstructions during the walkability assessments. Systematically addressing these sidewalk needs will require

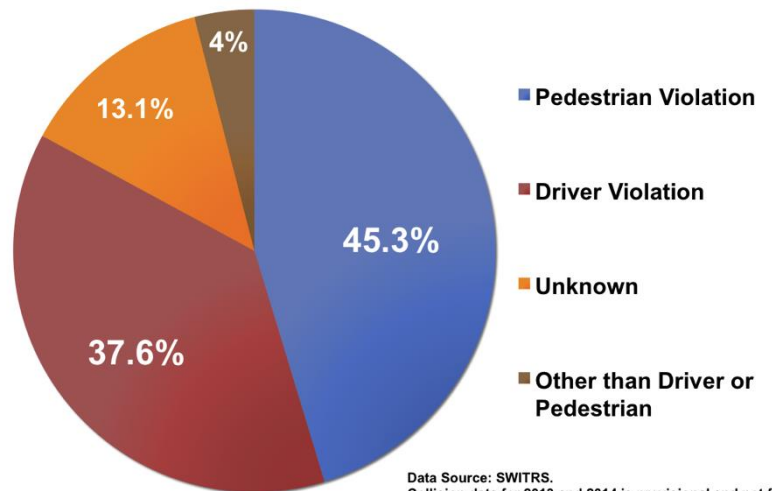
Pedestrian Collisions by Primary Collision Factor (PCF), (2010-2014)

Data Source: SWITRS. Collision data for 2013 and 2014 is provisional and not final.

in terms of driver violations were: Pedestrian Right-of-Way Violations² (60%) and Unsafe Speed (17%)—accounting for over three-quarters of driver violations found to be the PCF in pedestrian collisions. For pedestrian violations, the top two PCFs were: Failure to Yield to Drivers when Outside a Marked or Unmarked Crosswalk³ (79%), Disobeying a Pedestrian Signal⁴ (8%), and Walking on the Roadway⁵ (8%).

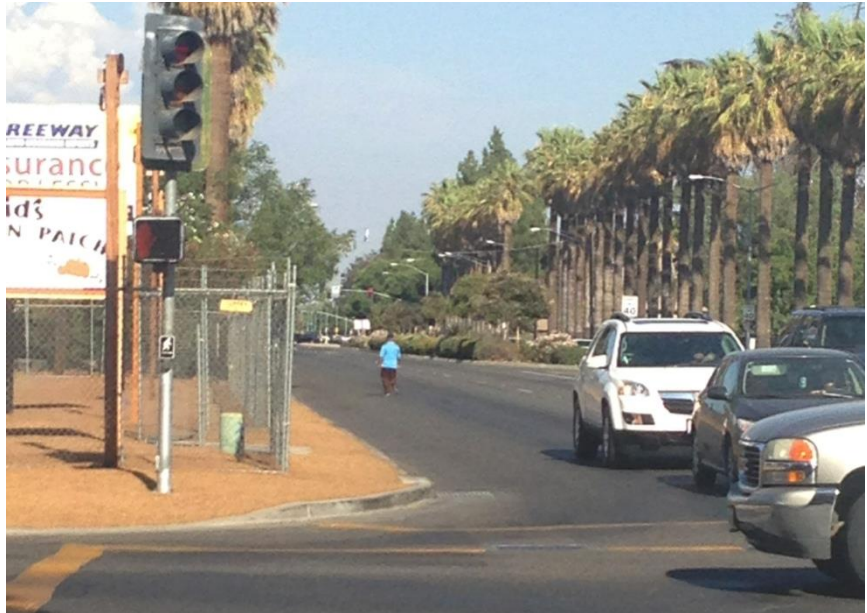
RESIDENT OBSERVED WALKING IN TRAFFIC ON KINGS CANYON ROAD DUE TO MISSING SIDEWALKS

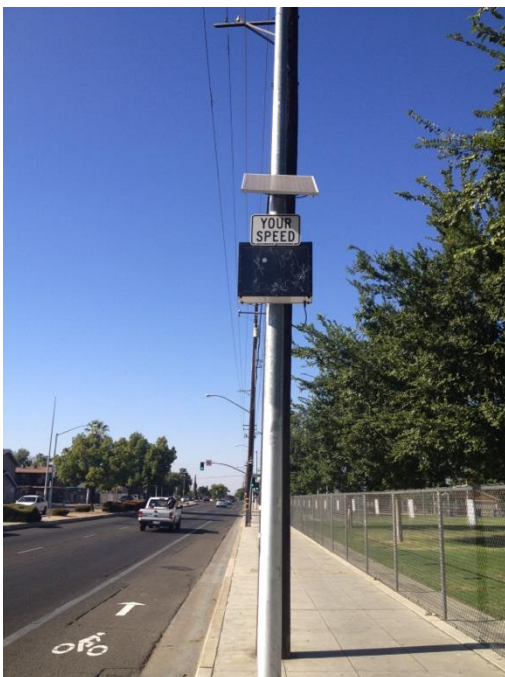
SPEED FEEDBACK SIGN IN DISREPAIR NEAR OLMOS ELEMENTARY

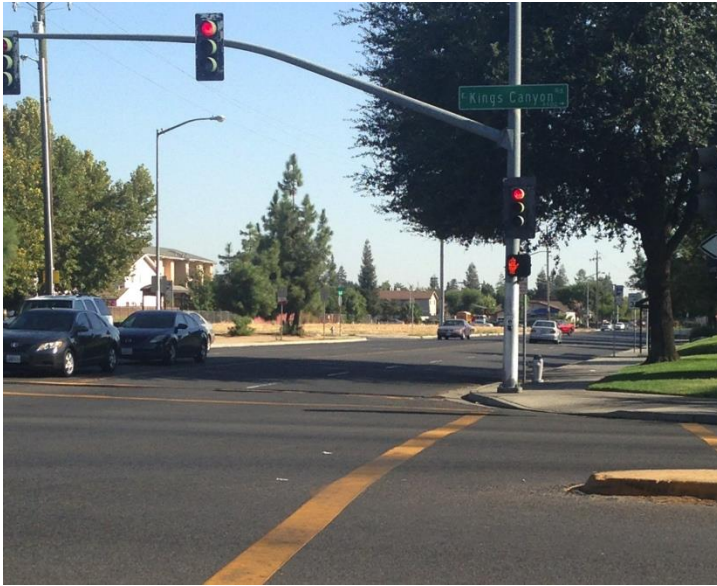
TRAFFIC MEDIAN OBSTRUCTS CROSSWALK ON KINGS CANYON ROAD

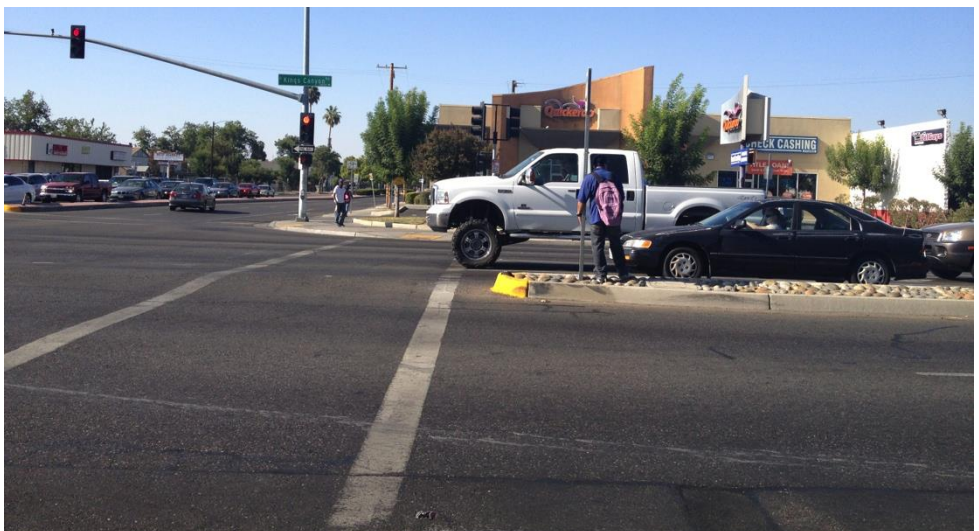
YOUNG STUDENT USES MEDIAN AS A REFUGE TO CROSS KINGS CANYON ROAD

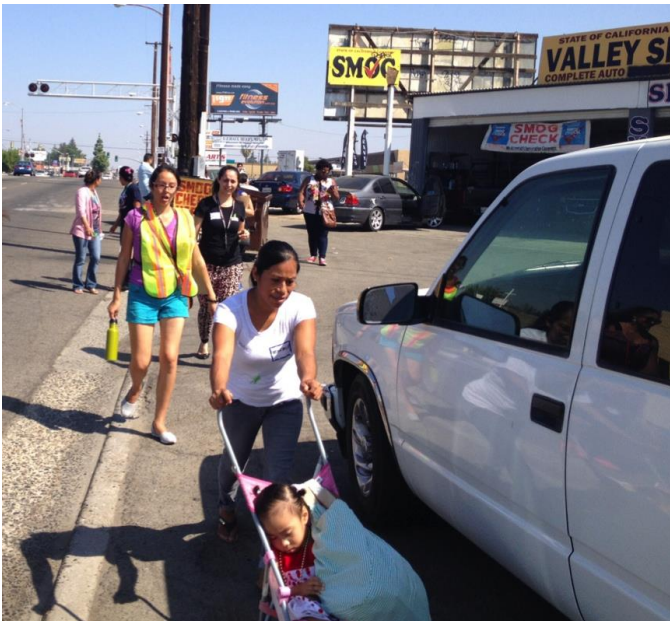
PARTICIPANTS NAVIGATE AROUND PARKED CARS AND OTHER ENCROACHMENTS ALONG BLACKSTONE AVENUE

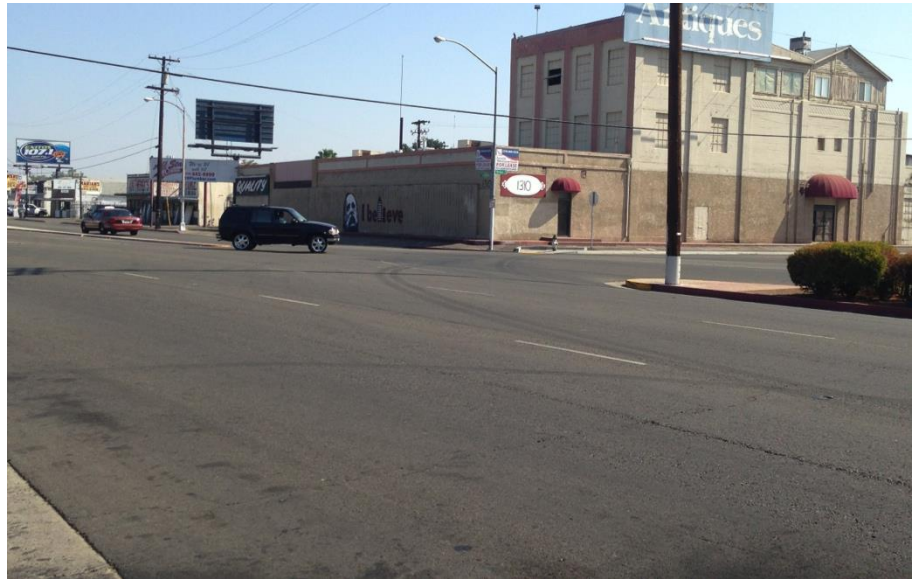
EXAMPLE OF THE NUMEROUS UNMARKED T-INTERSECTIONS ALONG BLACKSTONE AVENUE

- **Establish Comprehensive Midblock & Uncontrolled Crossing Policy:** Cal Walks and SafeTREC recommend that the City Department of Public Works develop a comprehensive pedestrian crossing policy for midblock and uncontrolled crossings in consultation with the City’s Bicycle Pedestrian Advisory Committee. Developing an objective, transparent policy that guides when the Department will install additional crossings will help educate residents about the process, as well as help set residents’ expectations. Example policies that could be used as a starting point include Washington County, OR’s Pedestrian Crossing Policy at Mid-Block and Uncontrolled Locations⁸ and Caltrans’ Crosswalk Enhancements Policy.⁹

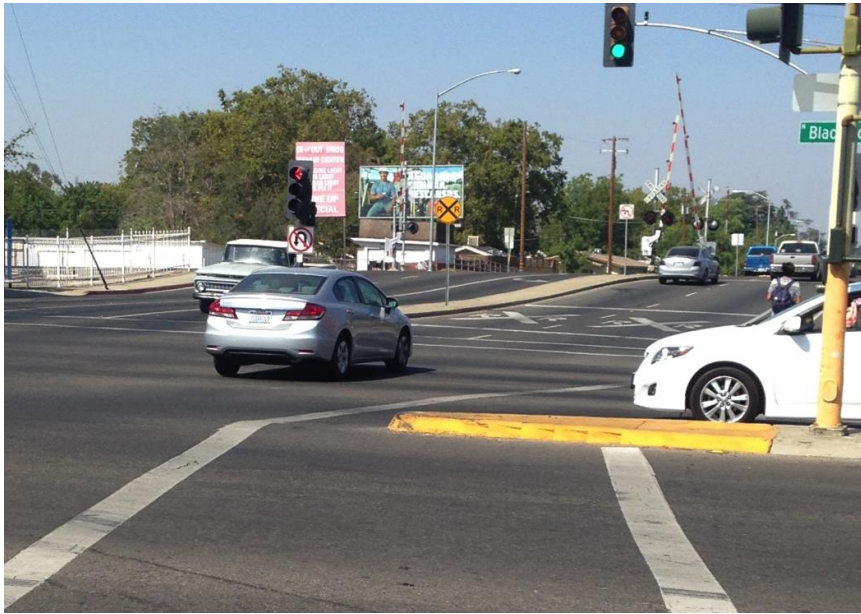
TRAFFIC MEDIAN OBSTRUCTS CROSSWALK ON BLACKSTONE AVENUE

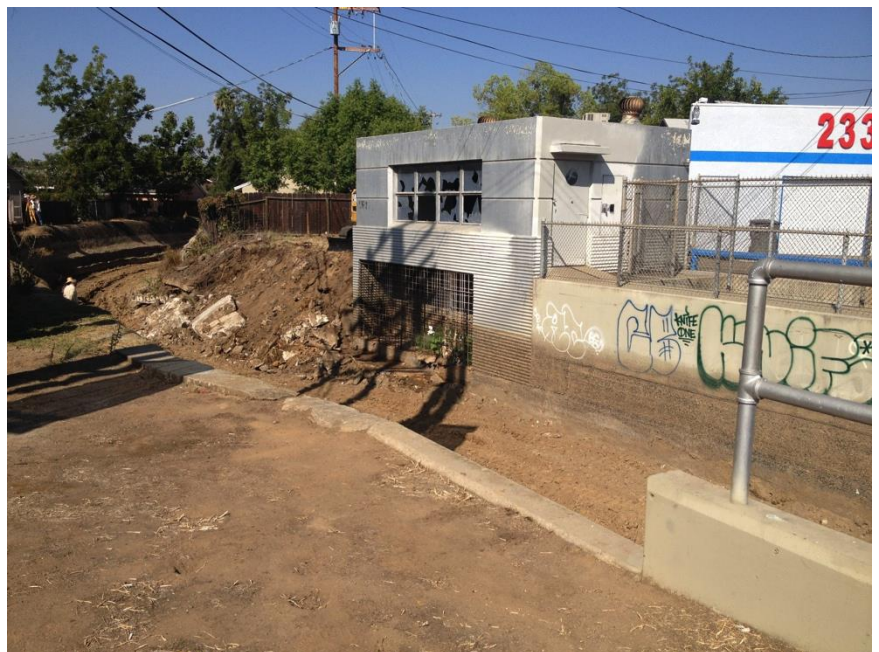
EXPOSED CANAL INVITES LITTER, GRAFFITI, AND BLIGHT

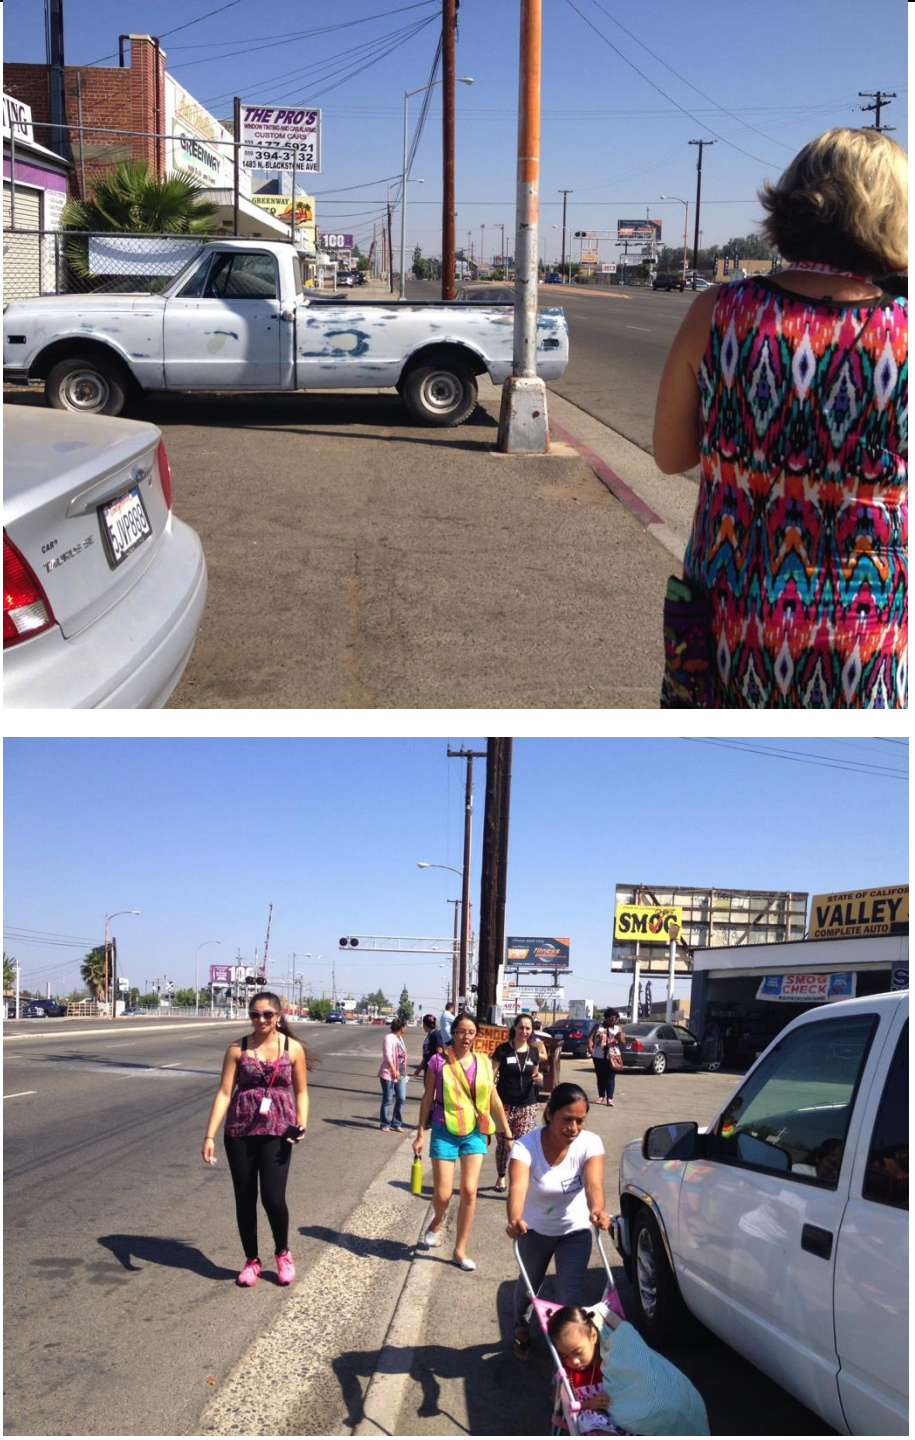
Infrastructure	Notes & Observations	Photos
<p style="text-align: center;">Missing Sidewalks</p>	<ul style="list-style-type: none"> • Sidewalks lacking on Home Avenue to the west of Blackstone Avenue • Sidewalk ends abruptly on east side of Blackstone Avenue between Home Avenue and McKinley Avenue • Missing sidewalk at Belmont Avenue and Abby Street • Sidewalks missing at Blackstone Avenue/McKinley Avenue and Blackstone Avenue/Weldon Avenue

<p>The top photograph shows a street scene with a white pickup truck parked on the side of the road. A utility pole is visible in the foreground, and a person wearing a colorful, patterned dress is seen from behind. In the background, there are commercial buildings, including one with a sign for 'THE PRO'S' and another for 'GREENWAY'. A sign for '100' is also visible.</p> <p>The bottom photograph shows a group of people walking on a street. A woman in a white shirt is pushing a stroller with a child inside. Other people are walking alongside her. A white pickup truck is parked on the right side of the street. In the background, there are commercial buildings, including one with a sign for 'SMOG' and another for 'VALLEY COMPLETE AUTO'. A sign for 'SMOG CHECK' is also visible.</p>

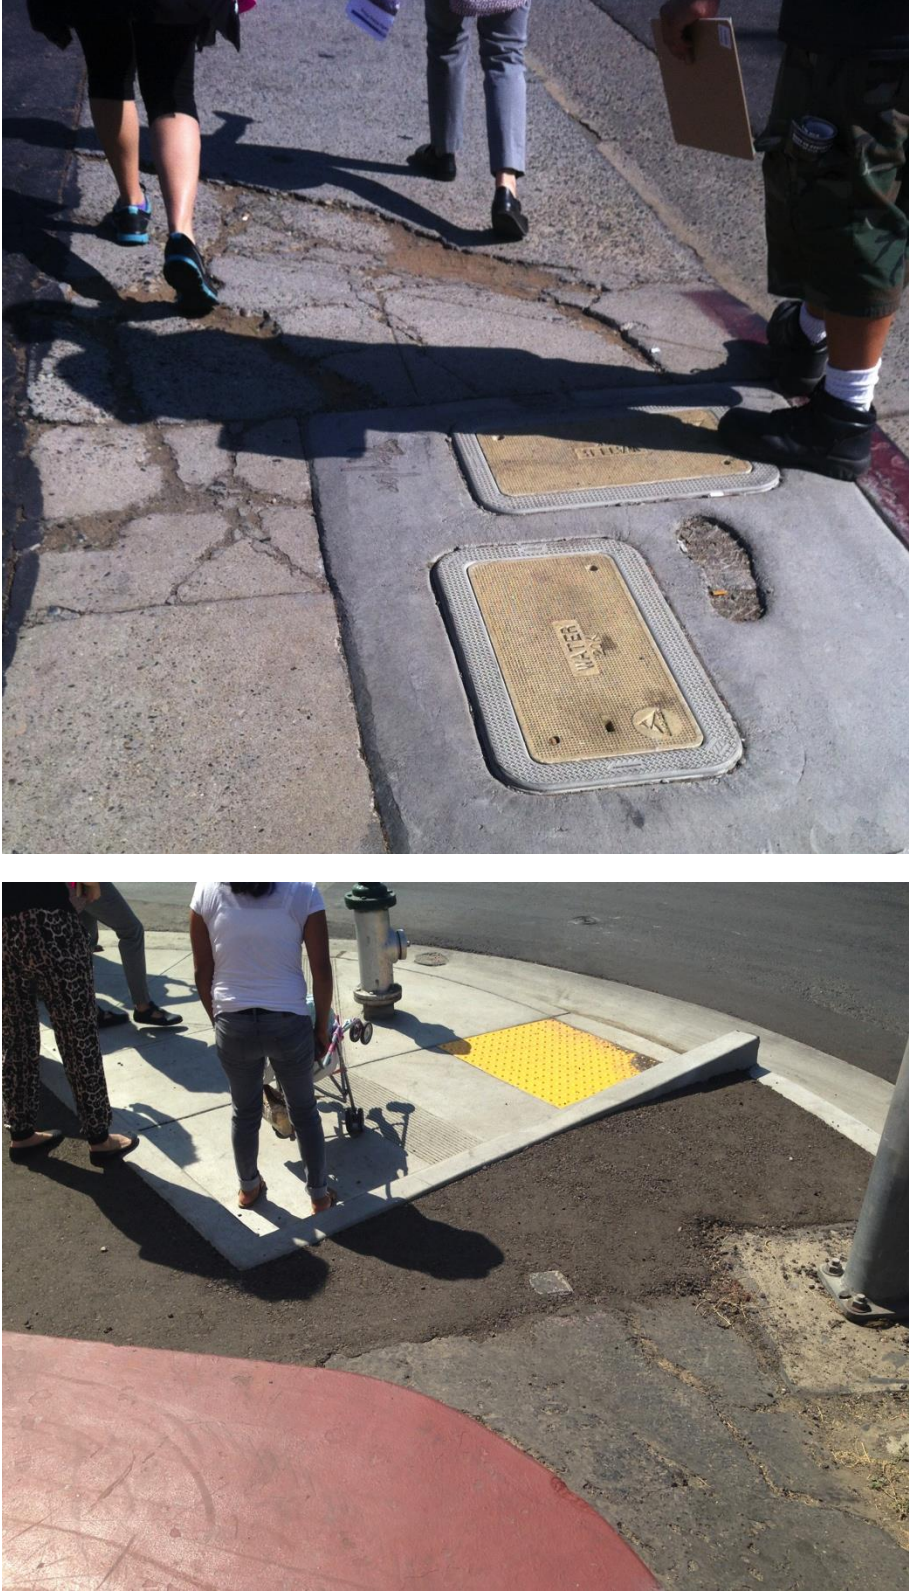
Infrastructure	Notes & Observations	Photos
<p>Sidewalk Maintenance</p>	<ul style="list-style-type: none"> • Lots of trees uplifting sidewalks • High-quality sidewalks including new ADA improvements in front of O'Reilly's • Tripping hazards due to sidewalk maintenance • Many areas that needed improvements were fixed with asphalt and not concrete • Poor condition at Blackstone Avenue and Lewis Avenue • Many uplifted sidewalks • Broken curbs • Traffic cone bolted to street light • Poor conditions on Blackstone Avenue and on McKinley Avenue • Sidewalks in disrepair due to trees • Blackstone Avenue & Olive Avenue: No fence on canal on west side of street

<p>The top photograph shows a close-up view of a sidewalk. In the foreground, there is a rectangular metal utility cover with the word 'WATER' embossed on it. To the right of the cover, there is a hole in the asphalt surface. In the background, the lower legs and feet of several people walking on the sidewalk are visible. The bottom photograph shows a sidewalk corner. A person in a white shirt and jeans is walking away from the camera, pushing a stroller. The sidewalk has a yellow tactile paving strip. A fire hydrant is visible in the background. The sidewalk is bordered by a red-painted curb on the left.</p>

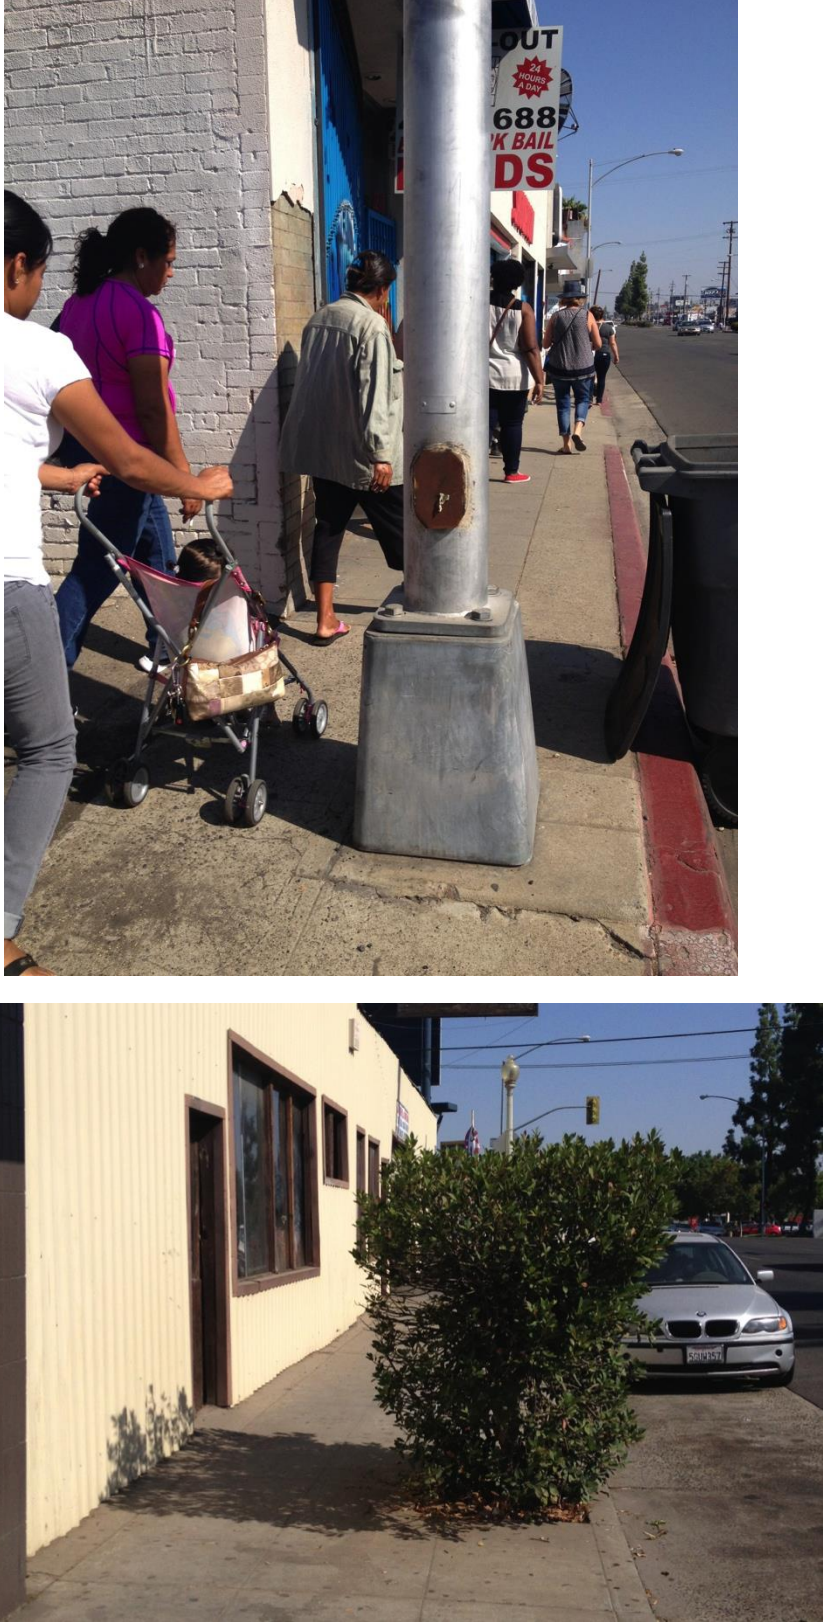
Infrastructure	Notes & Observations	Photos
<p>Sidewalk Obstructions</p>	<ul style="list-style-type: none"> • Utility/lighting pole in middle of sidewalk on west side of Blackstone Avenue just south of Pine Avenue • Many utility poles and signs take up sidewalk space • Not enough space to walk through area in front of Bail Shark Bail Bonds due to obstructions • Limited ramp space at Blackstone Avenue and Abby Street (southwest corner)

<p>The top photograph shows a utility pole positioned in the middle of a sidewalk. Several people, including a woman pushing a stroller, are walking past the pole. In the background, a sign for 'Bail Shark Bail Bonds' is visible, along with a street sign that says 'OUT 24 HOURS A DAY 688'. The bottom photograph shows a large, dense bush on a sidewalk next to a yellow building with windows. A silver car is parked on the street next to the bush.</p>

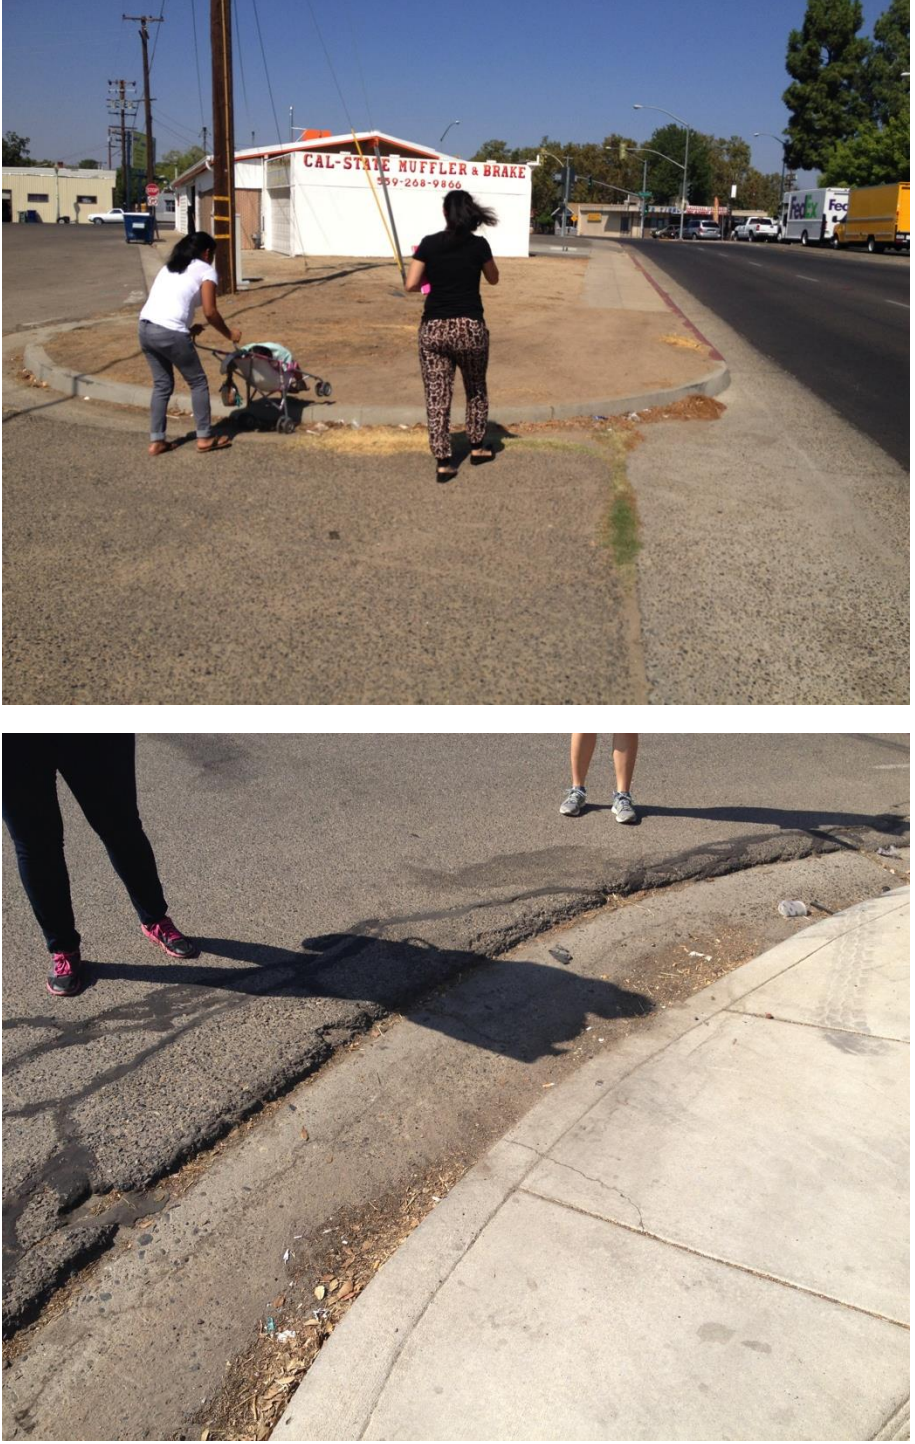
Infrastructure	Notes & Observations	Photos
<p>Curb Ramps</p>	<ul style="list-style-type: none"> • Ramp at Blackstone Avenue and Olive Avenue too small/narrow • Some ramps were not aligned with each other • Missing on eastbound CA-180 ramp • Curb ramp needs to be aligned with the crosswalk at Blackstone Avenue and University Avenue • Curb ramp not aligned with crosswalk at Blackstone Avenue and Olive Avenue • Some ramps lacked the detectable warning strips • O'Reilly auto parts: newer building, better design for curb ramps

<p>The top photograph shows a street intersection with a narrow curb ramp. A woman is pushing a stroller across the ramp, and another woman is walking nearby. In the background, a white building with a sign that reads "CAL-STATE MUFFLER & BRAKE" is visible. The bottom photograph is a close-up view of a curb ramp, showing a detectable warning strip (a textured surface) on the asphalt ramp leading up to a concrete sidewalk.</p>

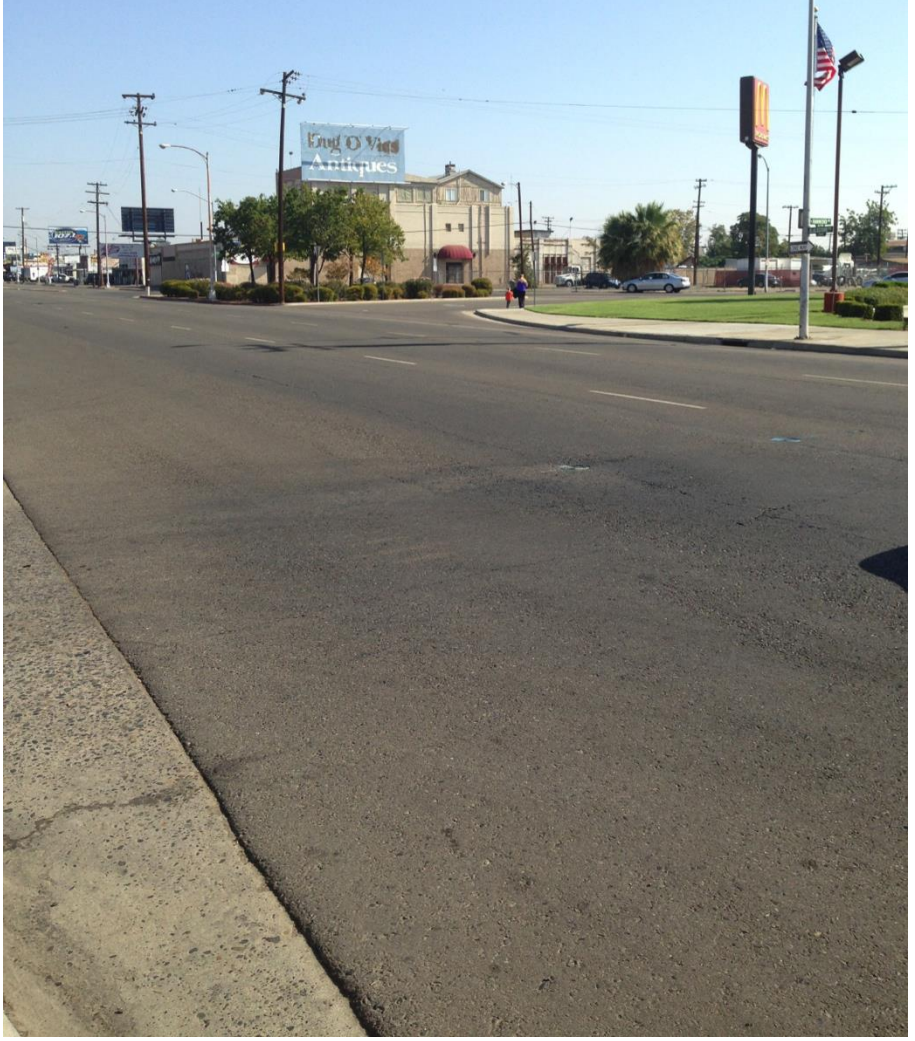
Infrastructure	Notes & Observations	Photos
<p>Crossing Distance</p>	<ul style="list-style-type: none">• McKinley Avenue and Blackstone Avenue: crosswalk markings are skewed• Some crossings are so wide that drivers cannot see people trying to cross• Dim light at southwest corner of McKinley Avenue and Olive Avenue

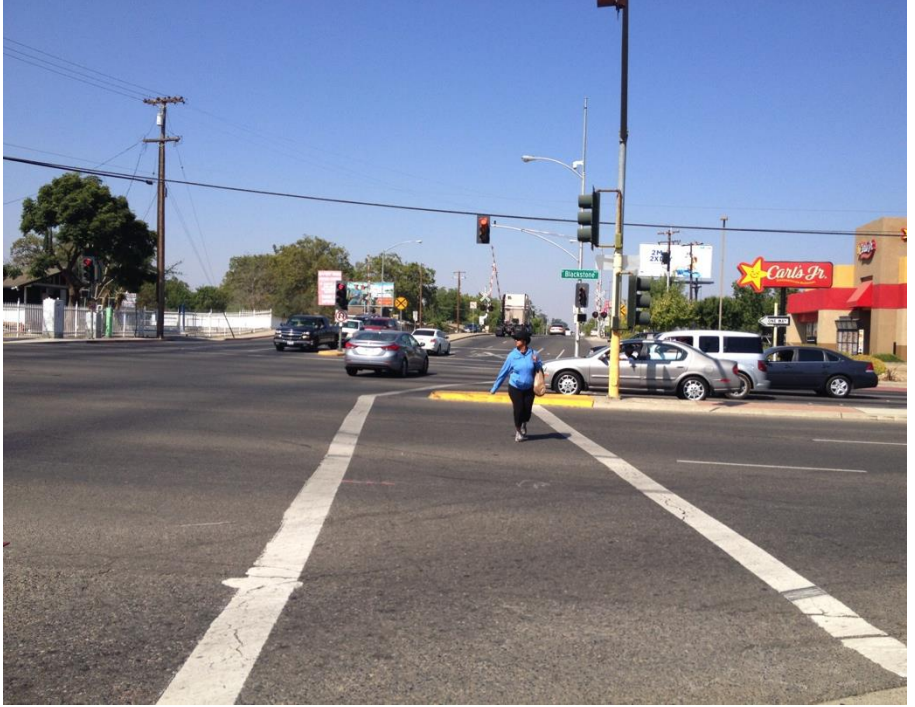
Infrastructure	Notes & Observations	Photos
<p>Crossing Time</p>	<ul style="list-style-type: none"> • Too short at Olive Avenue and Blackstone Avenue (noted at southwest corner) • Could use more time to cross • Some lights will take longer than usual or will not provide enough time to cross • Not enough time to cross at Blackstone Avenue/McKinley Avenue • Very short at Olive Avenue and Blackstone Avenue

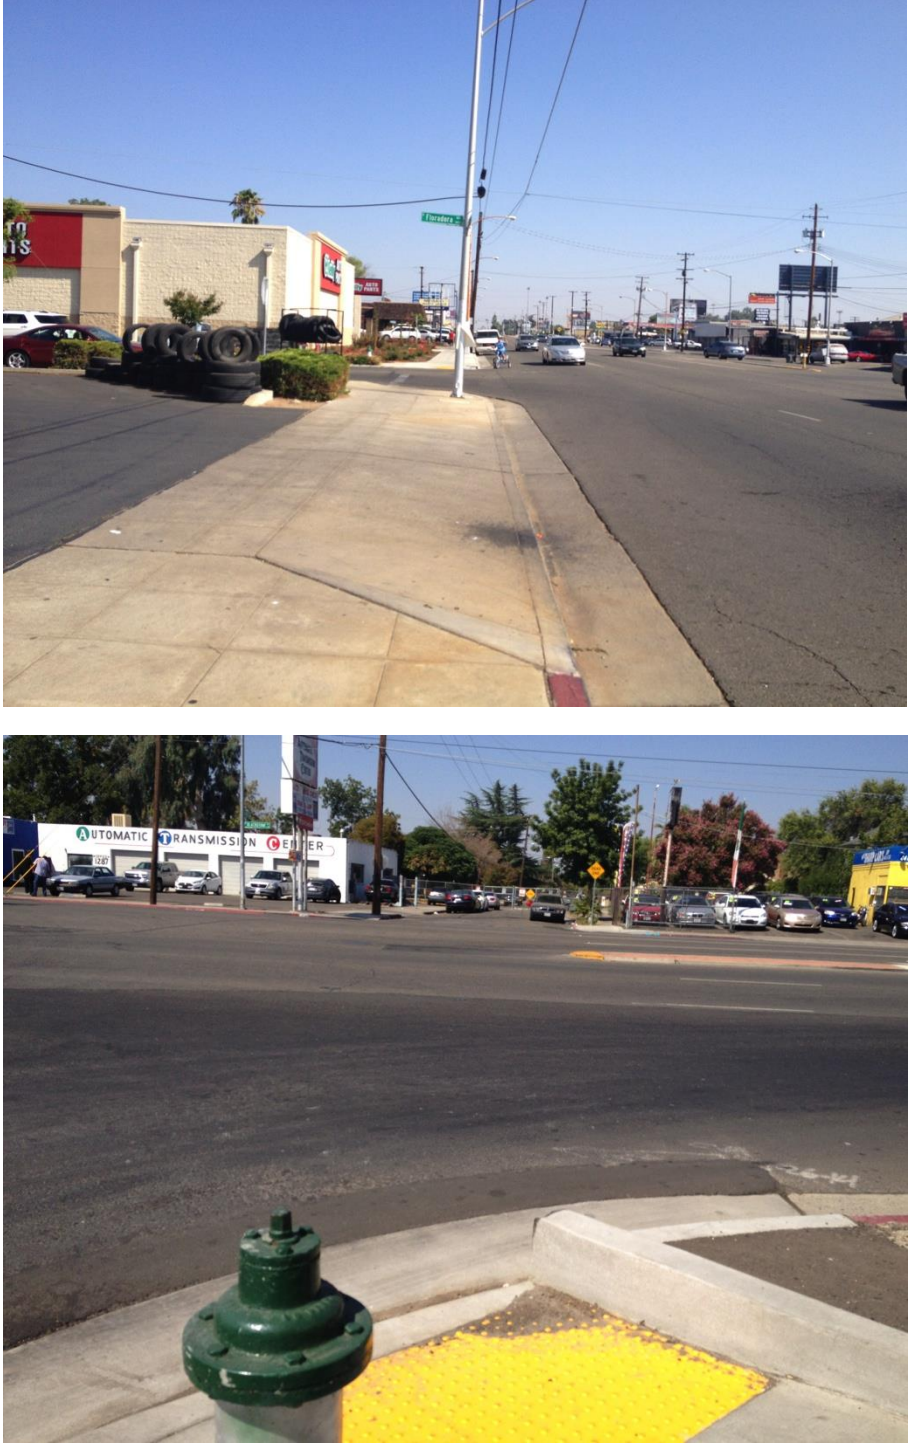
Infrastructure	Notes & Observations	Photos
<p>Crosswalk Markings</p>	<ul style="list-style-type: none"> • Crosswalks faded; need more high-visibility crosswalks • Distance between marked crosswalks is very long—may encourage people to “jaywalk” • Crosswalks should be upgraded to high-visibility markings • Only 1 marked crosswalk observed at Harvey Avenue • Numerous unmarked crossings; people have to use them because distance between marked crossings is very long • Many, many, many—at every T and at Clay Avenue and Abby Street, no marked crosswalks across Abby • There needs to be a marked crosswalk at Blackstone Avenue/Hedges Avenue and Blackstone Avenue/University Avenue, Blackstone Avenue/Pine Avenue, Blackstone Avenue/Home Avenue • In the commercial area, there aren’t any marked crossings to help kids get to school • Too many unmarked crosswalks, especially considering how fast drivers are going • Need to mark crossing for children at Clay Avenue and Blackstone Avenue • No marked crossing near McDonald’s • No marked crossing at Weldon Avenue and Blackstone Avenue (northeast and northwest crossing)

<p>The top photograph shows a wide, multi-lane street with a concrete sidewalk in the foreground. A utility pole stands on the sidewalk. In the background, there are commercial buildings, including one with a red sign, and several cars on the road under a clear blue sky.</p> <p>The bottom photograph shows a street intersection. In the foreground, a green fire hydrant is visible on a concrete curb. A section of the curb is painted yellow. In the background, there is a white building with signs for 'AUTOMATIC TRANSMISSION CENTER' and several cars parked or driving on the street.</p>

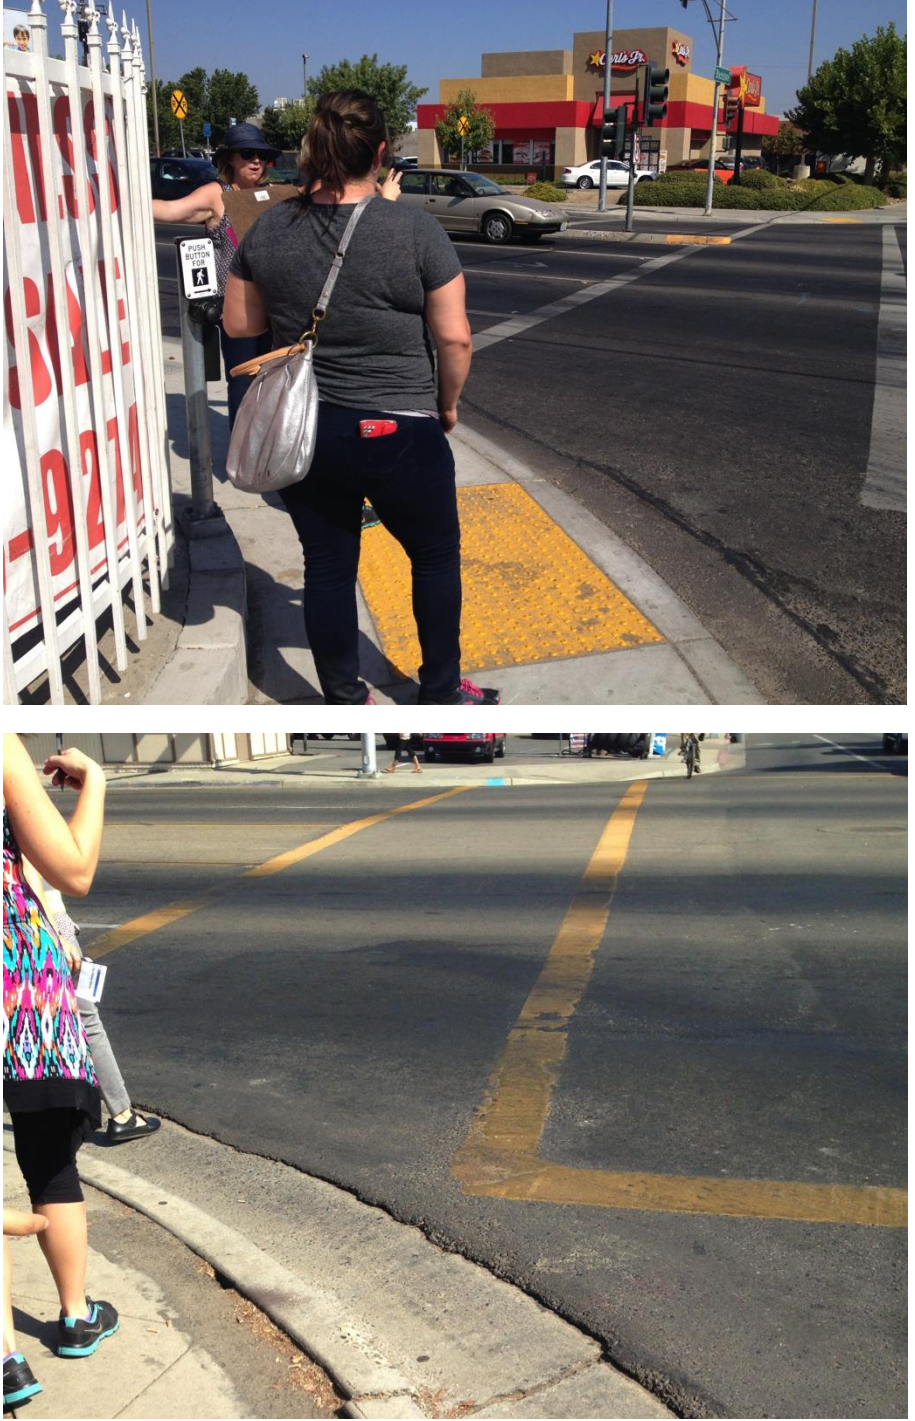
Infrastructure	Notes & Observations	Photos
<p>Crosswalk Maintenance</p>	<ul style="list-style-type: none"> • Crosswalks poorly marked and maintained at Blackstone Avenue and Home Avenue • All marked crosswalks encountered need to be repainted • Some marked crosswalks encountered could be greatly improved with minimal effort • Need more marked crosswalks around Susan B. Anthony Elementary School and Fresno City College • Poor pavement quality on Abby Street • The signage and markings near the school need to be improved

<p>The top photograph shows a woman in a grey shirt and black pants standing at a crosswalk. To her left is a white metal barrier with red and white diagonal stripes. A sign on the barrier reads 'PUSH BUTTON FOR' with a wheelchair icon. The crosswalk has a yellow tactile strip. In the background, there is a building with a 'Culpa Pro' sign and a traffic light.</p> <p>The bottom photograph shows a crosswalk with faded yellow markings on a paved street. A person in a colorful patterned shirt is partially visible on the left side of the frame.</p>

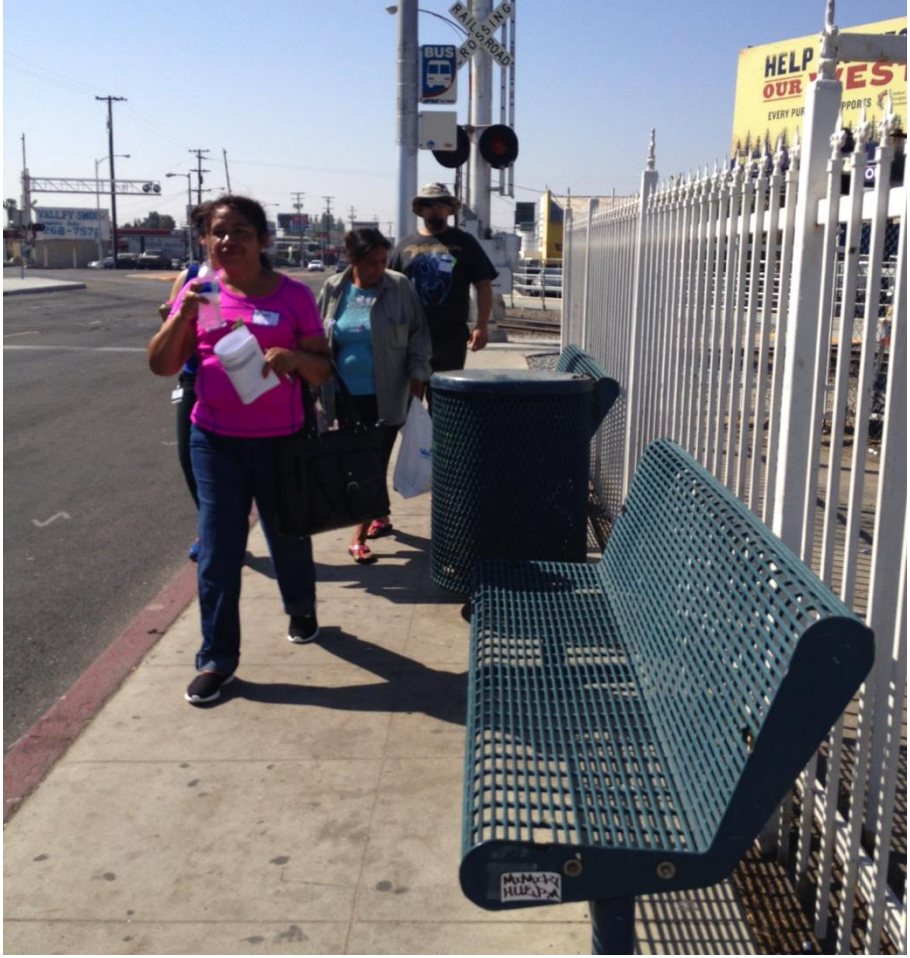
Infrastructure	Notes & Observations	Photos
<p>Bulb Outs / Curb Extensions</p>	<ul style="list-style-type: none">• Need more bulb outs near bus stops so buses aren't impeding traffic

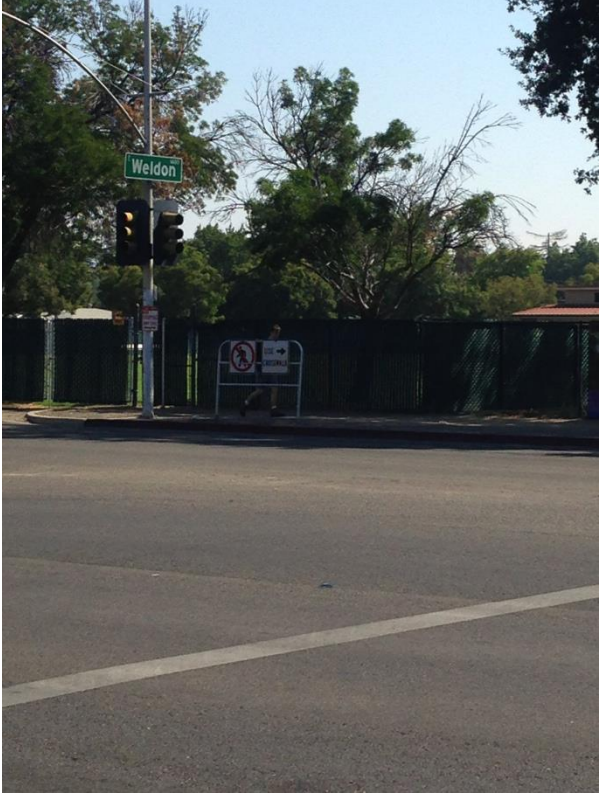
Infrastructure	Notes & Observations	Photos
<p>Pedestrian Signals & Countdown Timers</p>	<ul style="list-style-type: none"> • Did not encounter any timers • Would like to see prioritized for installation at high traffic locations • Had to manually push buttons to cross (Blackstone Avenue/McKinley Avenue)

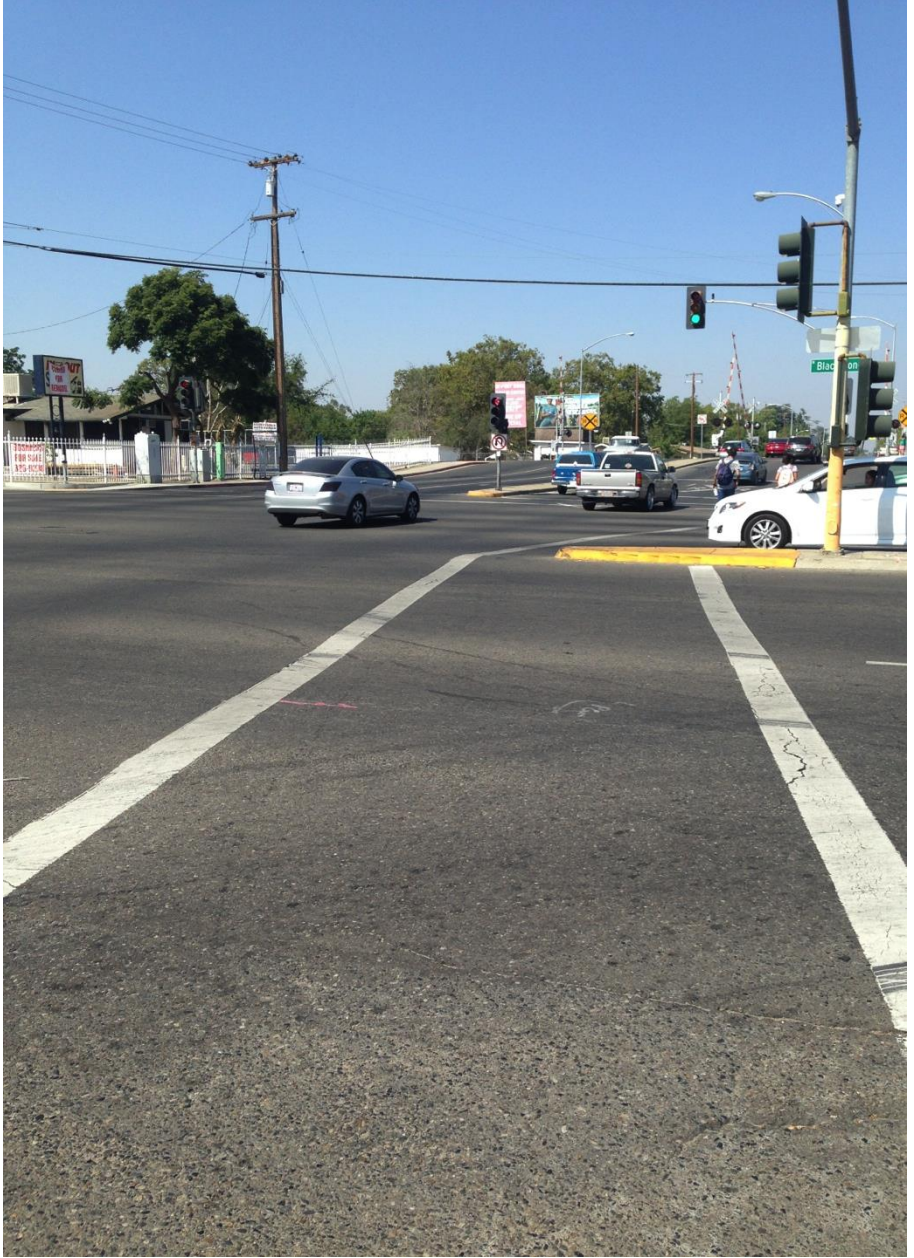
Infrastructure	Notes & Observations	Photos
<p>Pedestrian Safety Island</p>	<ul style="list-style-type: none"> Existing medians are very narrow, some median noses impede into the crosswalk and push pedestrians into traffic Extend existing median at Abby Street/Olive Avenue to create safety island
